4 GREENE DREHER DAM
WAYNE COUNTY, PENNSYLVANIA

NDS I.D. NO. PA 00174
DER I.D. NO. 64-174

6 PHASE I INSPECTION REPORT
NATIONAL DAM INSPECTION PROGRAM,
NDS I.D. Number PA-00174.
DER I.D. Number 64-174.
Delaware River Basin, Greene Dreher
Dam, Wayne County, Pennsylvania.
Phase I Inspection Report.

Name of Dam:	Greene-Dreher Dam
County Located:	Wayne
State Located:	Pennsylvania
Stream:	Manny Run
Coordinates:	Latitude 41° 15.1' Longitude 75° 21.8'
Date of Inspection:	25 October 1978

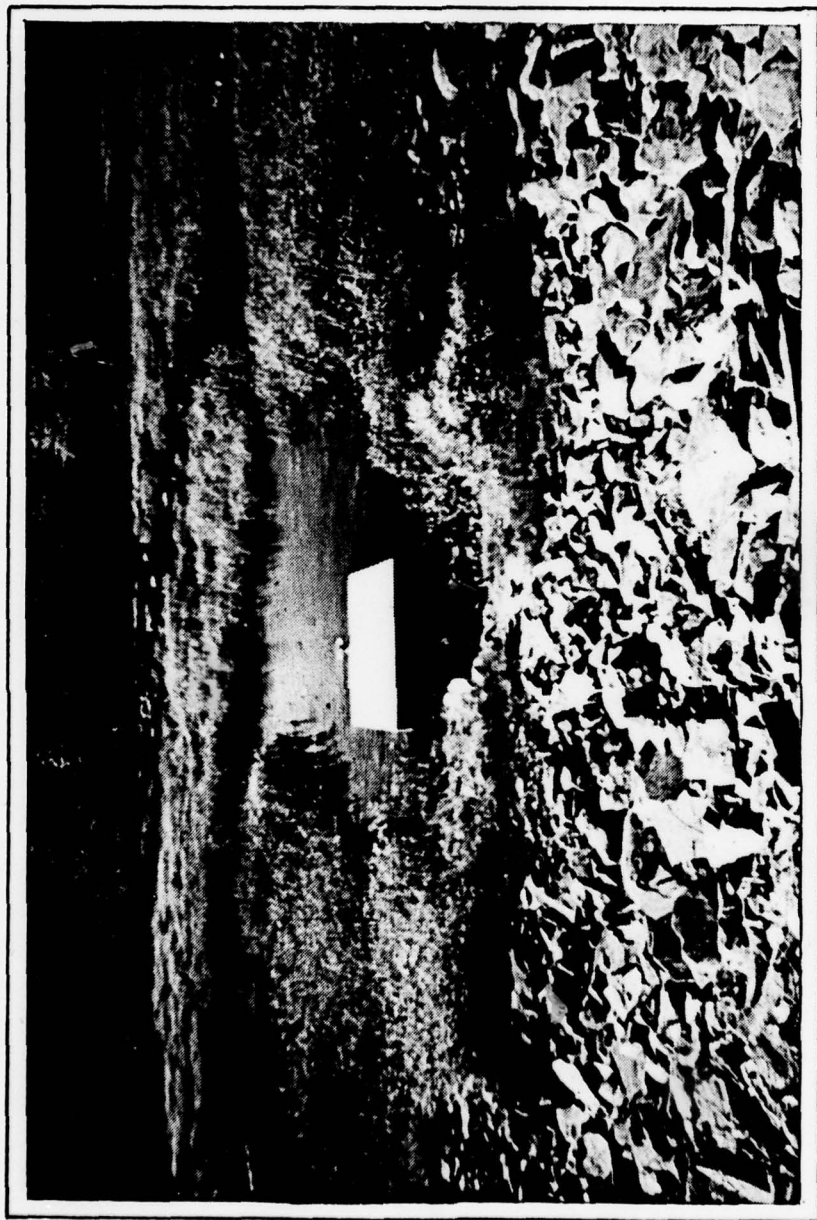
PHOTOGRAPH NO. 1

1. Principal Spillway. There was no cracking or significant spalling observed on the intake riser. The discharge conduit could not be inspected, but the exposed portions of the riser and the conduit were carefully inspected and observed to be in good condition. One trash rack pipe was missing on the right side of the intake riser, which can be seen in Photograph No. 2. The rock-lined outlet channel, as

INTAKE RISER AND PRINCIPAL SPILLWAY.

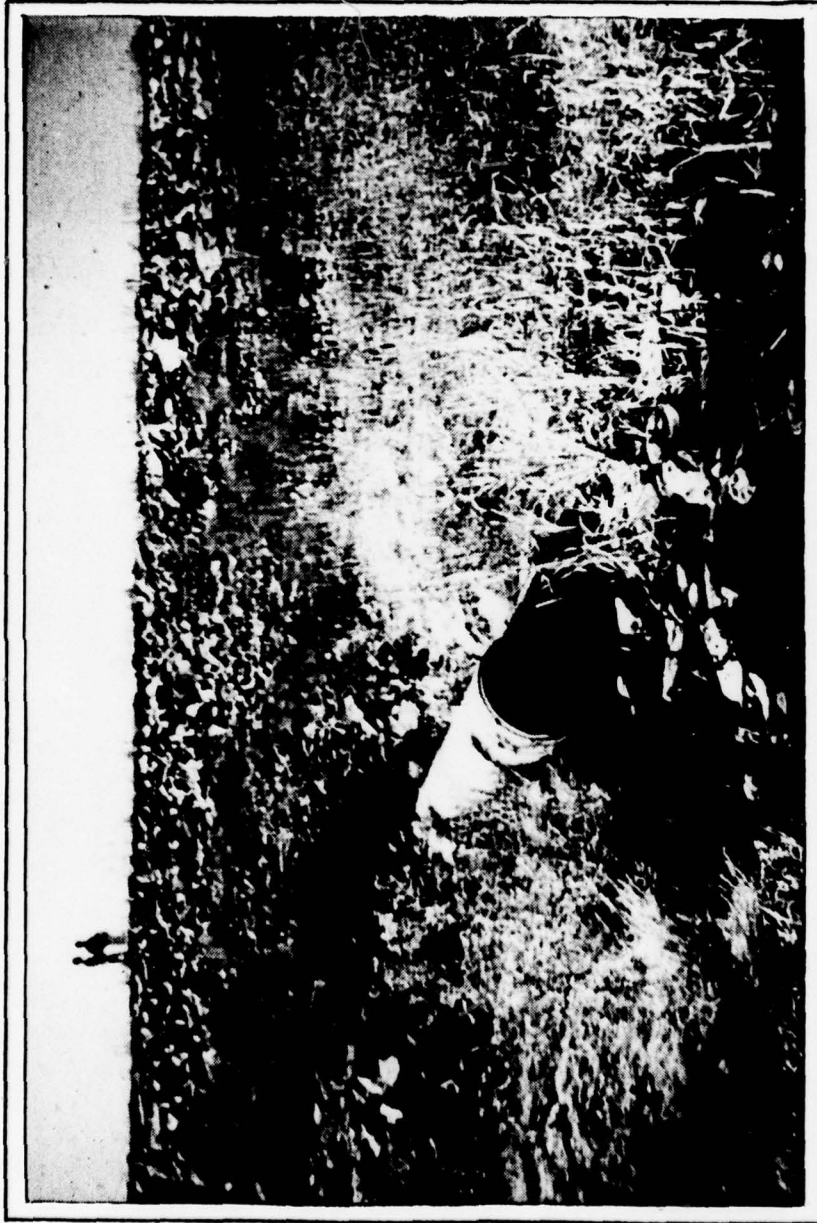
PHOTOGRAPH NO. 3

OUTLET PIPE FOR PRINCIPAL SPILLWAY.

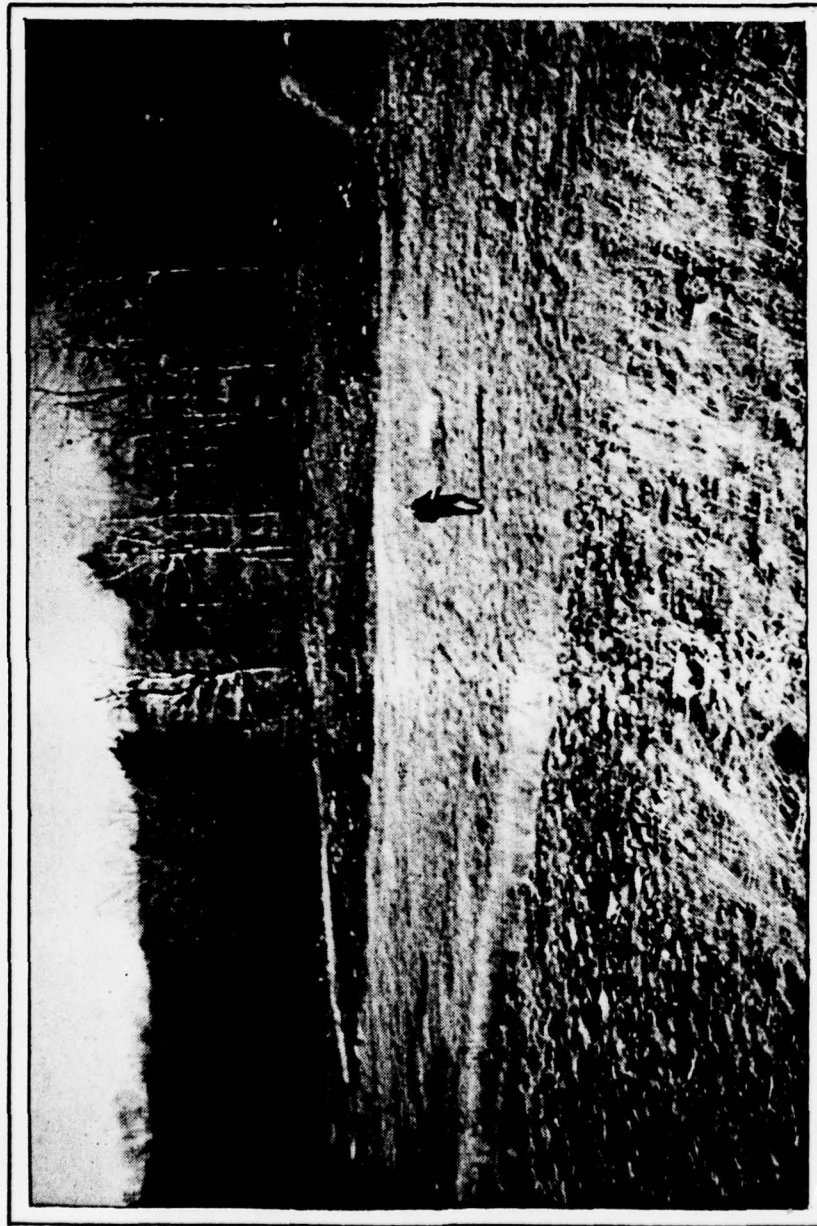
PHOTOGRAPH NO. 5

OVERVIEW OF EMERGENCY SPILLWAY
LOOKING UPSTREAM FROM LEFT END
OF EMBANKMENT.

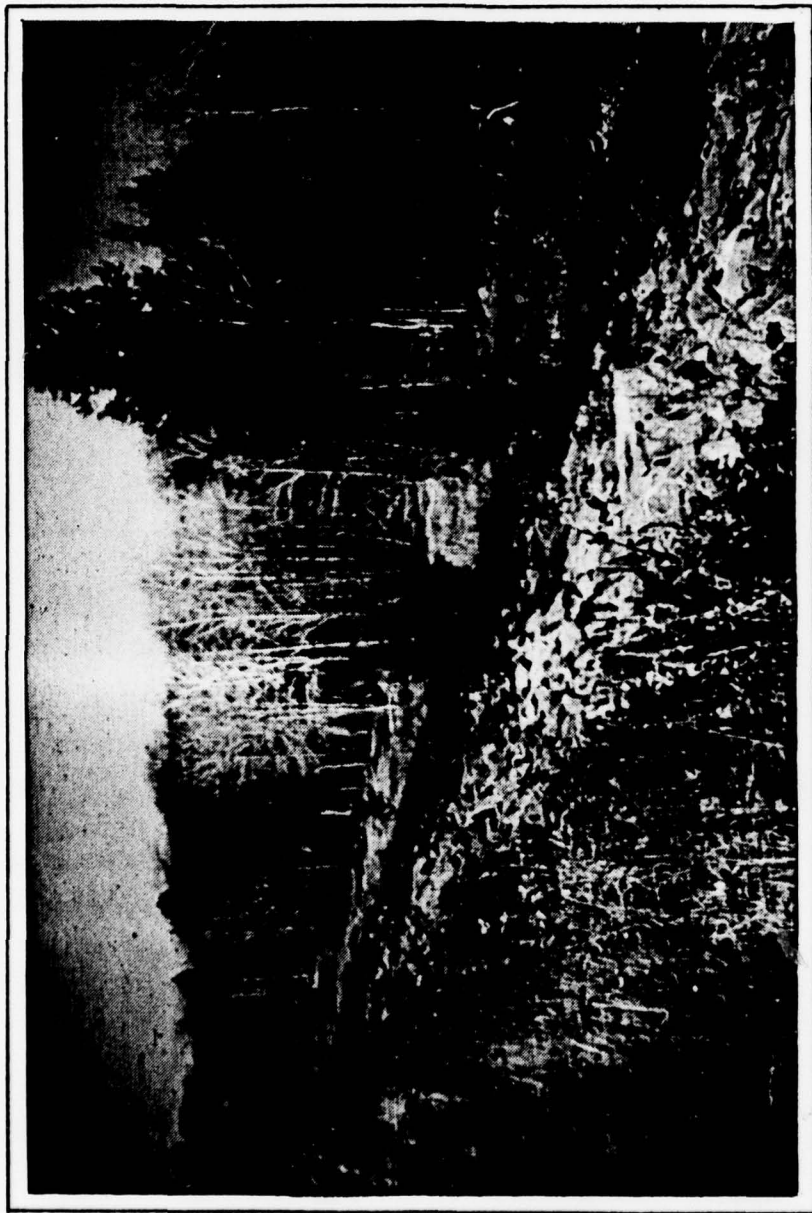
PHOTOGRAPH NO. 7

There was no spalling or concrete deterioration of the exposed portions of the principal spillway riser or conduit observed. The upstream slope of the dam was assessed to be quite stable and the woody vegetation recently removed. The downstream slope had a few small evergreen trees growing on the slope, which should be removed in the near future.

OVERVIEW OF DOWNSTREAM SLOPE.

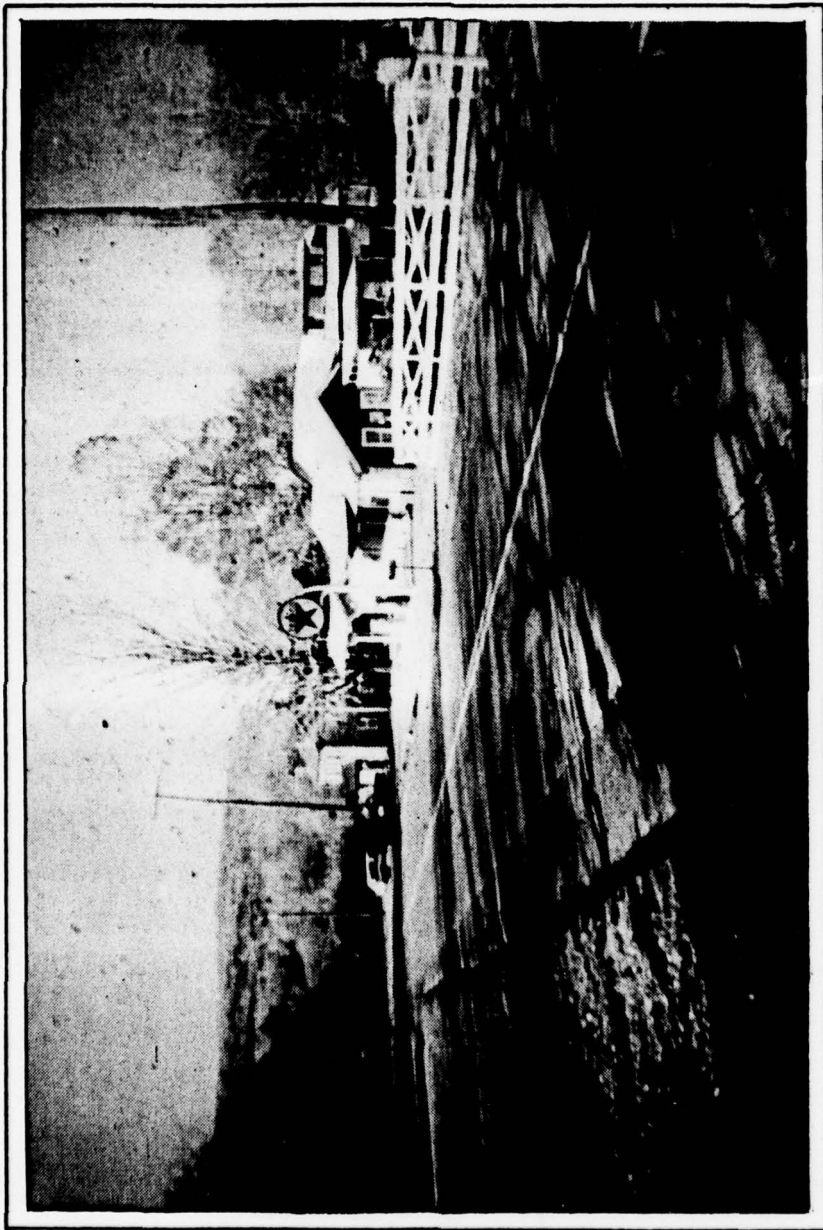
PHOTOGRAPH NO. 10

e. Downstream Channel. The downstream channel was inspected from the dam to Route 196 and found to be unobstructed and quite stable. Between Route 196 and the junction of Manny Run with Routes 423 and 191, the creek was not inspected in that it passed through a dense wooded area which was not reasonably accessible. However, the creek was inspected at the damage center (intersection of Manny Run and Route 423) and the banks were found to be stable. A view of the bridge at the damage center is shown on Photograph No. 8. The houses that would be affected by high flows are shown on Photograph No. 10.

POPULATED AREAS ALONG ROUTE 191
ADJACENT TO MANNY RUN.
